## **ITAIPU DAM**

## **General Information**

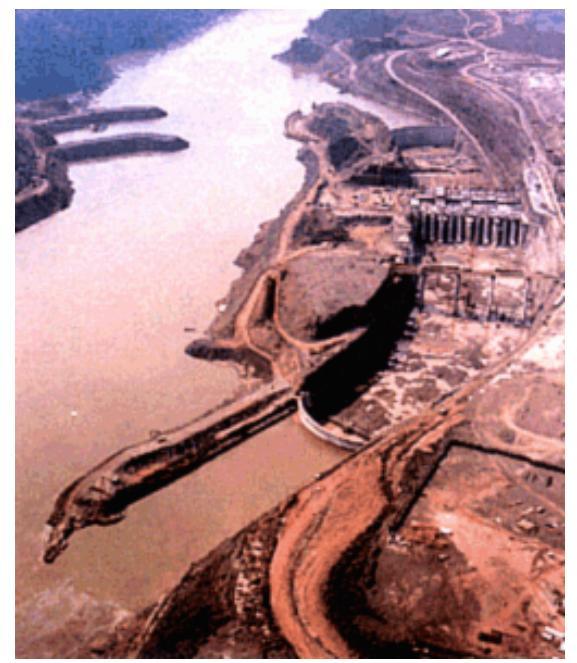
Diversion of the Paraná river was achieved by the construction of a channel 2 km long, 150 m wide, and 90 m deep on the left river bank. A diversion structure aligned with the main dam was built in the channel before the diversion of the river. Two arch dams were built to protect the channel structures from floods. The diversion structure used mass concrete and had 12 temporary diversion openings that were designed to pass a maximum flood of 30,000 m<sup>3</sup>/s without overtopping the upstream and downstream cofferdams. Later, the diversion structure was converted into intake structure for the power house. (Photograph courtesy of Itaipu Binacional)

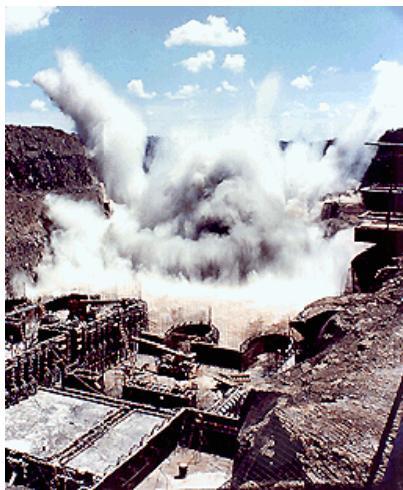
Once the structures of in the diversion channel were finished, the two arch dams built to protect the structures from flood were simultaneously exploded in just 3 seconds. This was an important stage for the diversion of the river (Photograph courtesy of Itaipu Binacional)

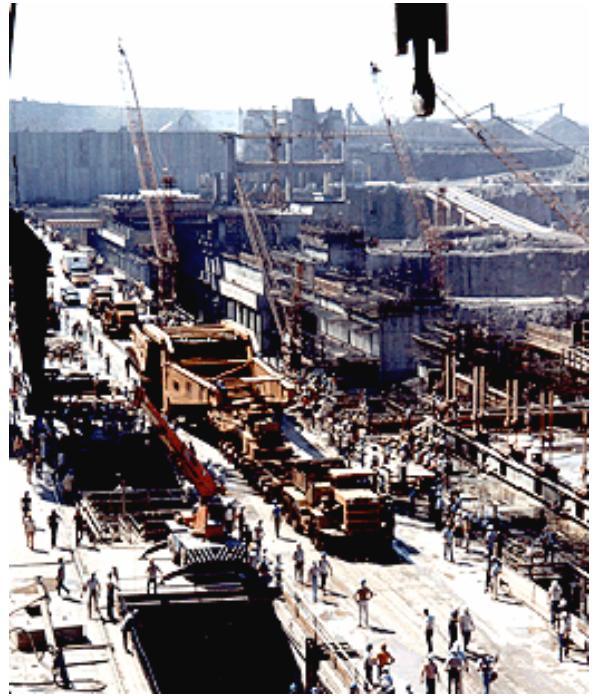
The foundation of the dam consisted of Mesozoic igneous rock consisting of basalt and basaltic breccia. Geologically eight flows were identified as important for design. A concern was the discontinuities of the layers between these flows because of their low friction angle.

The main dam was instrumented to analyse its performance during construction and operation. The instrumentation included foundation piezometers, extensometers, stress meters, clinometer, direct and inverted pendulums, thermometers, and joint meters. (Photograph courtesy of Itaipu Binacional)

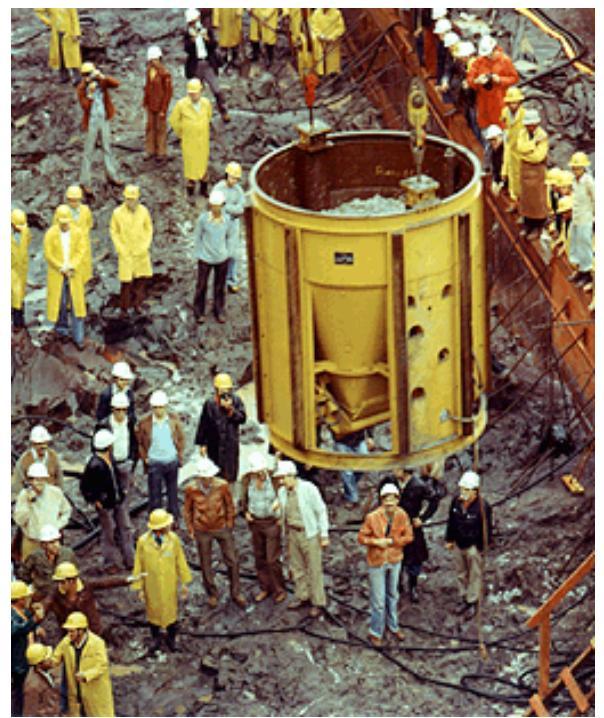
Seven aerial cables with an span of 1300 m were used for transporting concrete in 8 m<sup>3</sup> buckets. In November of 1979, a monthly production of 340,000 m<sup>3</sup> was achieved. In 1980, the yearly production was 3 million cubic meter.

Three major classes for mass concrete were used in the main dam. In the zones of high compressive stress of 6 MPa, concrete with compressive strength of 28 MPa at year was specified. In less stressed zones, concrete with compressive strength of 21 and 14 MPa at year were used. (Photograph courtesy of Itaipu Binacional)

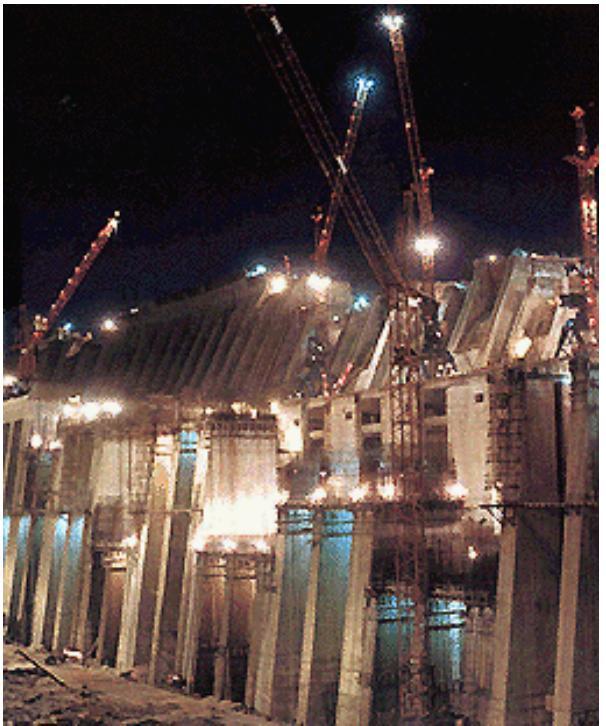
The concrete blocks were built monoliths separated by inclined contraction joint. The joints were afterwards keyed and grouted. Concrete was placed in 2.5-m thick lifts. (Photograph courtesy of Itaipu Binacional)

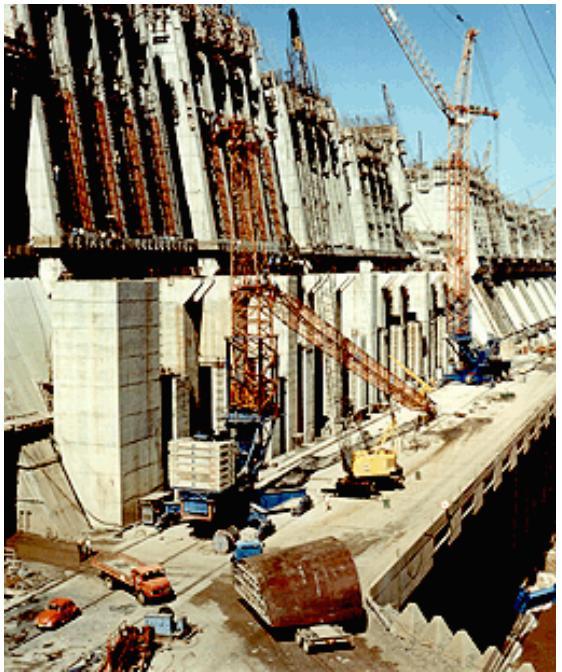
The blocks of the intake dam were built with upstream and downstream slopes of 0.58 H:1.00 V and 0.46 H:1.00V, repectively. Fourteen blocks, 34 m wide, each with two butresses of varying width were built in the intake dam. (Photograph courtesy of Itaipu Binacional)

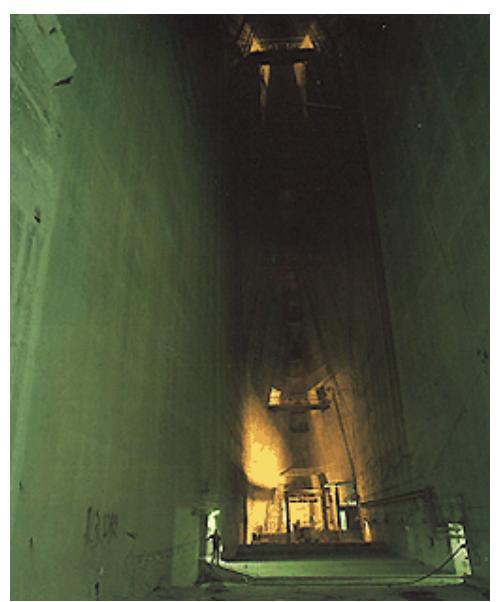
To reduce the amount of concrete in the dam, the center of the block is hollow. (Photograph courtesy of Itaipu Binacional)

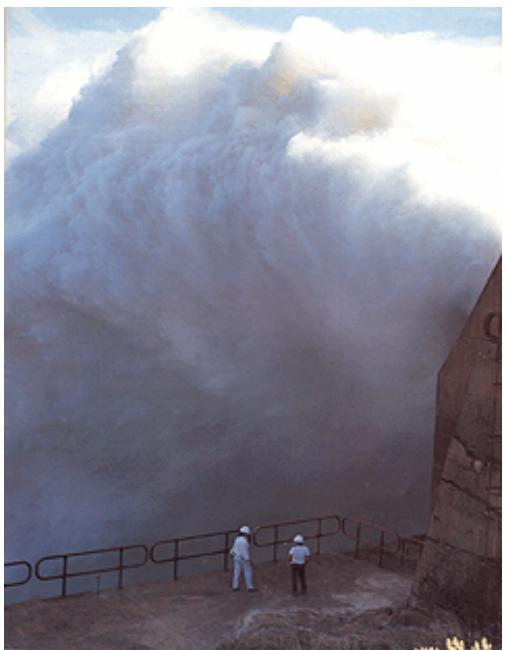
The spillway, with a length of 483 m, was designed for a maximum discharge capacity of 62,220 m3/s. Fourteen gates 21m high and 20 m wide were used. (Photograph courtesy of Itaipu Binacional)
