Microscopy of Delayed Ettringite Formation

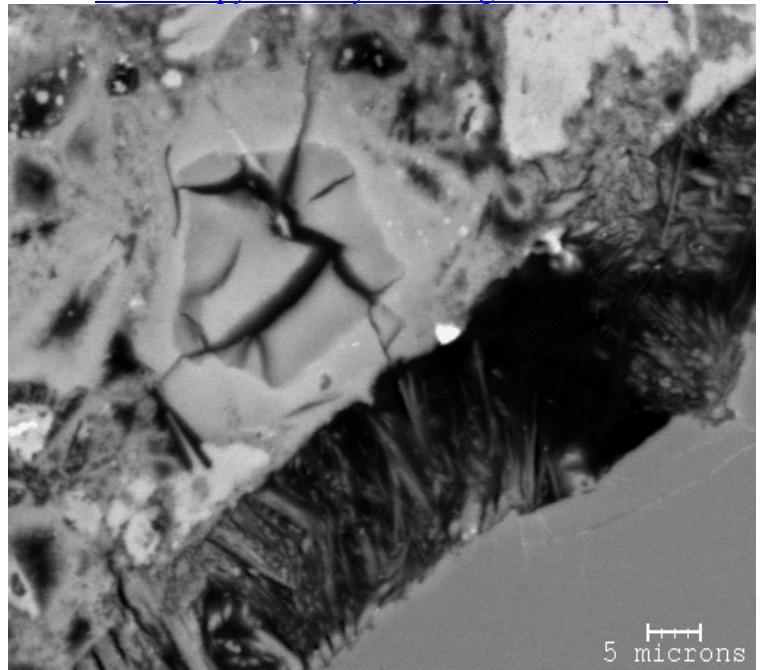
High magnification image of Fig. *. Internally cracked fully hydrated cement grain exhibiting the two-tone C-S-H rims. The microcracks have started from the darker C-S-H core and spread further in the lighter rim (micrograph courtesy of C. Famy).

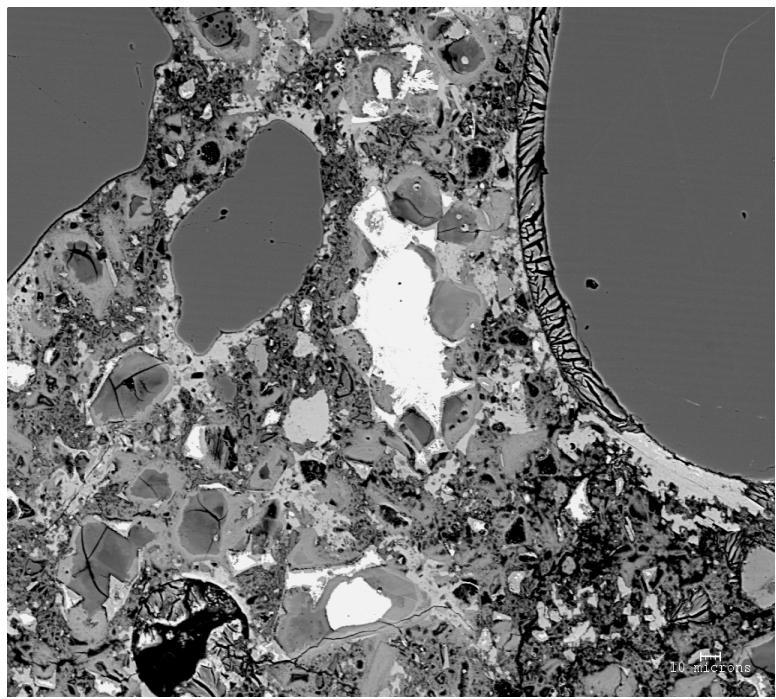
Ettringite forms in gaps and in air-voids. Some unreacted ferrite phases can be observed (very bright). Sample stored for 4 hours at 20°C, heated at 90°C for 12 hours and subsequently stored in water for 600 days (micrograph courtesy of C. Famy).

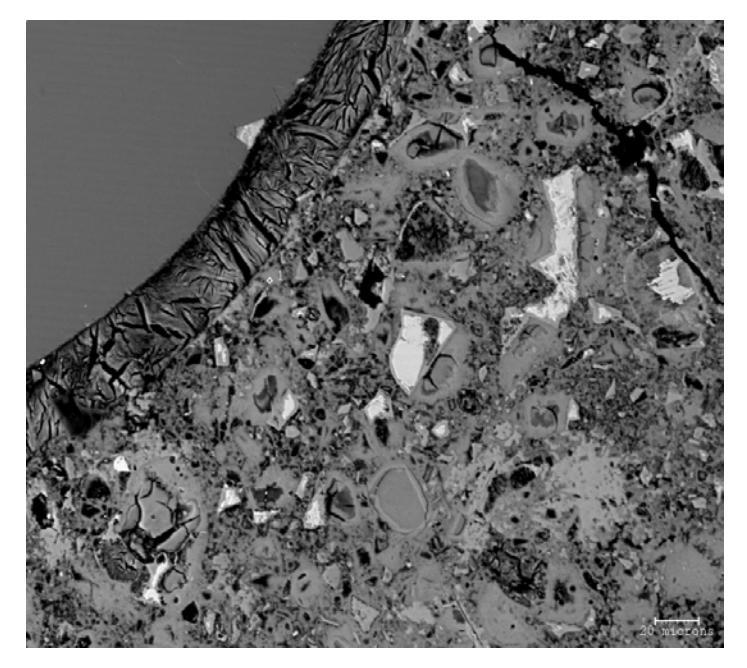
Sample stored for 4 hours at 20°C, heated at 90°C for 12 hours, subsequently stored in water for 600 days and then reheated at 90°C for 12 hours and stored in water for 30 days. Upon subsequent exposure to water for 30 days, all the calcium monosulfoaluminate has transformed to ettringite which is observed mainly surrounding the aggregates. Unreacted ferrite and partly hydrated belite grains are still present (micrograph courtesy of C. Famy).
